# Manhole Inspection Summary

Manhole # **S29C\_\_030MH**

Insp Date: **4/22/09 4:55 PM**

**Location** Address: **701 CHERRY BLOSSOM WAY** Cross Street: **SARATOGA ST**

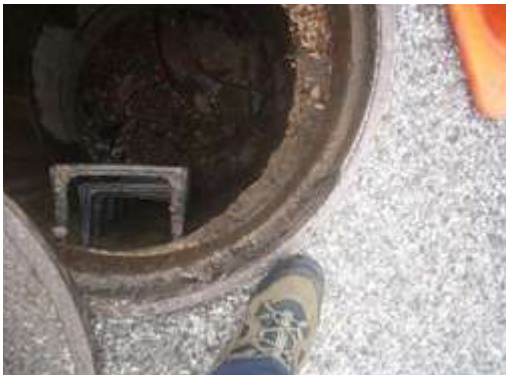
Defect 1

**Frame** Offset: **3** (in.) Condition: ☒ Sound ☐ Cracked ☐ Leaks

FRAME OFFSET

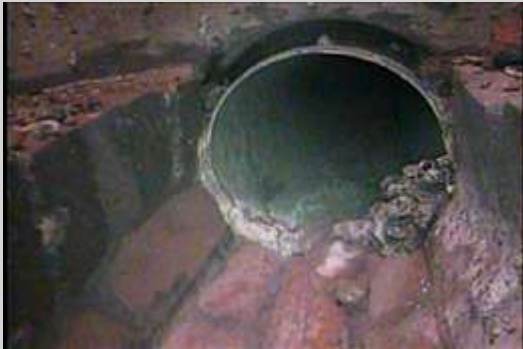
12 O'Clock Outflow

8 in. Circular Gravity Sewer  
Pipe Out @ 12 O'Clock

Pipe Height: **8.4** (in.) Rod and Bar (Angled)  
Pipe Material: **PVC** ☐ Pipe Lined  
Invert Depth: **10.23** (ft.) Flow Characteristics: **Slow**  
Deposits: ☐ None ☐ Mud ☒ **Sludge** ☐ Debris ☐ Grease  
Silt Depth: **2** (in.) Deposits Extent: **Light**  
Infiltration: **None** Pipe Seal Cond: **Sound**

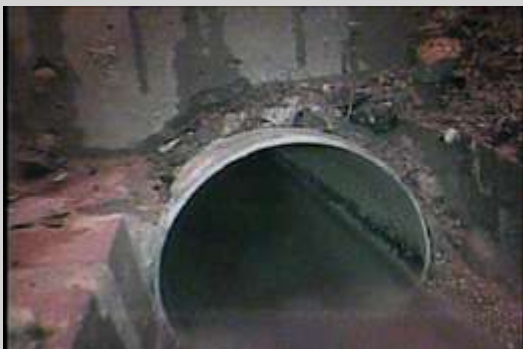
3 O'Clock Inflow

8 in. Circular Gravity Sewer  
Pipe In @ 3 O'Clock

Pipe Height: **8.4** (in.) Rod and Bar (Angled)  
Pipe Material: **PVC** ☐ Pipe Lined  
Invert Depth: **9.81** (ft.) Flow Characteristics: **Slow**  
Deposits: ☒ None ☐ Mud ☐ Sludge ☐ Debris ☐ Grease  
Silt Depth: (in.) Deposits Extent:  
Infiltration: **None** Pipe Seal Cond: **Sound**
